How to Avoid Corrosion and Cracking of Plates

The Negative Effects of Using Non-Alfa Laval Adhesives

Case Story

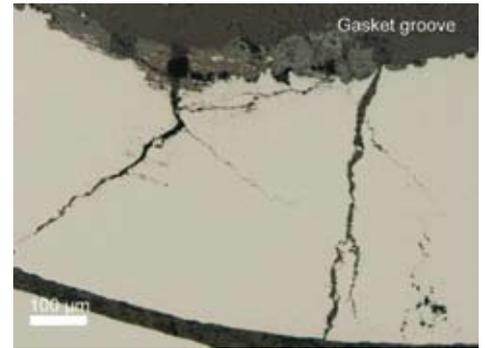
It was determined that the stress corrosion cracking and severe localized corrosion were caused by the use of chloride-containing glue used for fixing

Stress corrosion cracks in the V85 plate. The dark grey objects on the upper side of the plate piece are corrosion products.

To ensure that the products work as efficiently, effectively and with as long a life as possible, it is strongly recommended that only Alfa Laval approved adhesives are used. This will make sure that potentially damaging elements are not conflicting with the products.

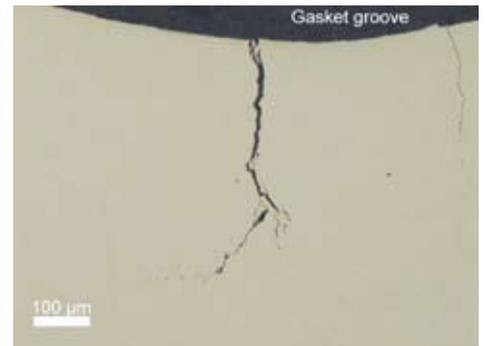
Stress corrosion cracks in one of the V170 plates.

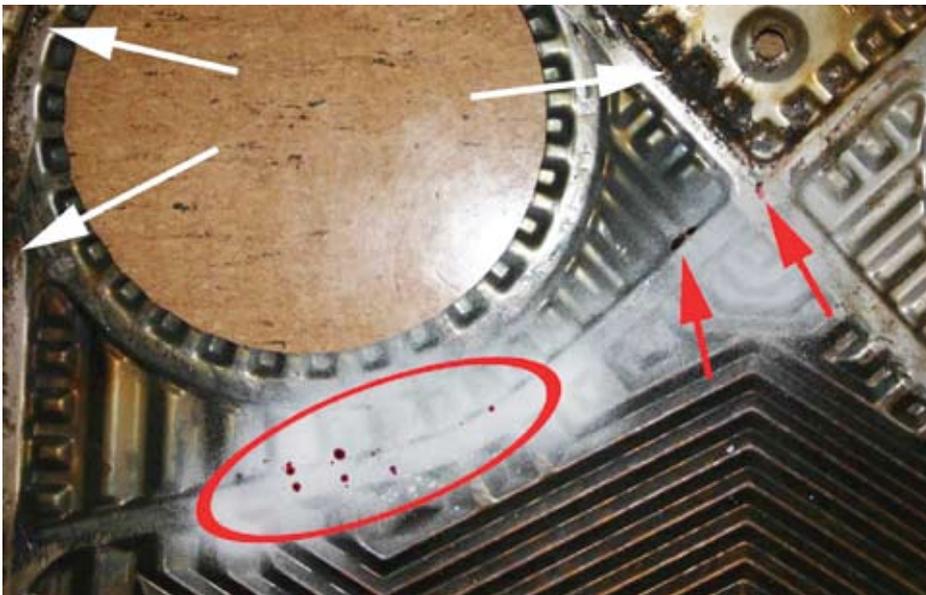
- EDS analysis of glue residuals used for fixing the gaskets in the gasket grooves revealed substantial amounts of chloride.
- The red dye penetrant applied to the V85 plate revealed several perforations in and near the gasket groove.
- The media-exposed surfaces were not affected by corrosion. It was noted that glue residuals were present in substantial amounts outside the gasket grooves.
- The metallographic cross sections revealed several branched cracks, characteristic of stress corrosion type of cracking (SCC).
- EDS analysis showed that there were substantial amounts of chloride present.
- The flame test gave clear, positive indications of the presence of chlorides in the glue, which also appeared in the EDS analysis.

V85 plate. In addition to the obvious and severe corrosion and cracking along the outer gasket groove (marked with arrows), the use of red dye penetrant revealed numerous perforations along the gasket diagonal, shown as red spots (highlighted by the red arrows and in the encircled area.)

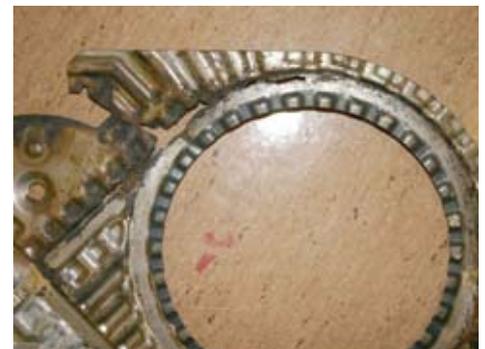
All three plate pieces showed similar advanced corrosion and cracking. The damages were mainly located at the gasket grooves and on the non-media exposed surfaces, e.g. the leakage chamber. The laboratory examination included the following findings:

V85 plate. The damages are mainly located in the gasket grooves.
