## How to not let fouling bog you down

### Compabloc improves performance in an ammonia plant

### Case story

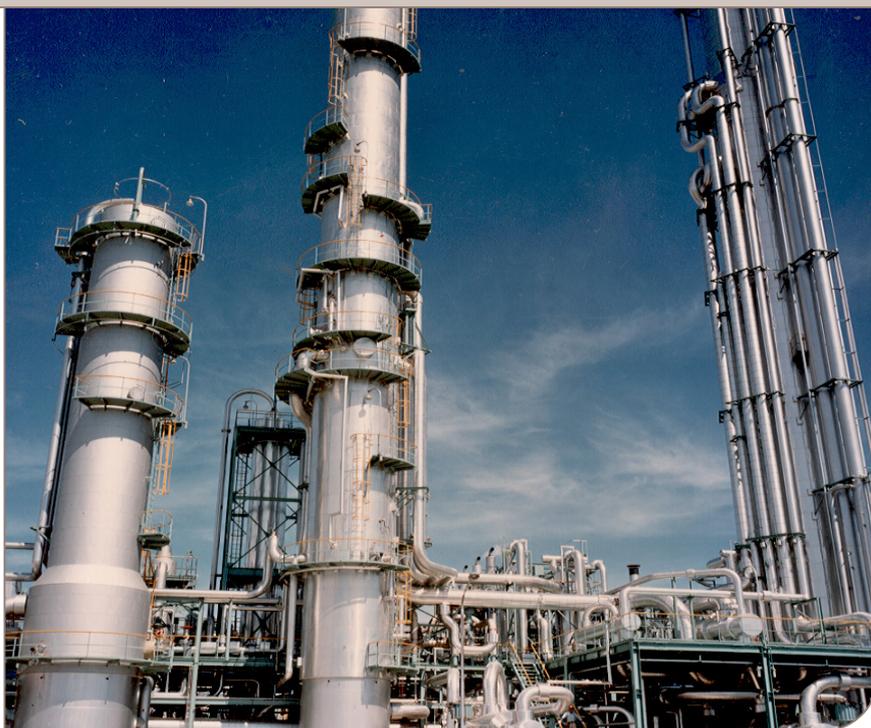
A Compabloc operates with a crossing temperature program and a temperature approach as low as 3°C (5.4°F). So significantly more energy is recovered than with shell-and-tube heat exchangers.

This makes Compablocs suitable for heat recovery positions, for example as lean/rich interchangers. A Compabloc operates with a crossing temperature program and a temperature approach as low as 3°C (5.4°F). So significantly more energy is recovered than with shell-and-tube heat exchangers.

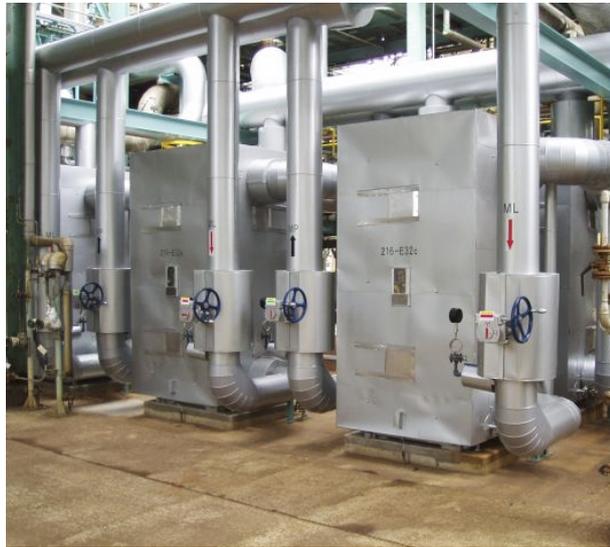
Replacing their existing coil-wound heat exchanger with four Alfa Laval Compablocs eliminated the severe fouling problems the plant struggled with before.

Replacing their existing coil-wound heat exchanger with four Alfa Laval Compablocs eliminated the performance problems caused by severe fouling – and incomplete cleaning – that the plant struggled with before.

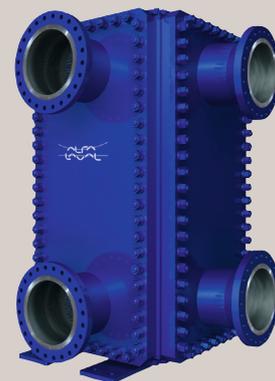
**Compabloc heat exchangers**

Compabloc heat exchangers provide efficient heat transfer in compact equipment with a small footprint. The units have a flexible design and are easy to service and maintain.

The Compabloc fully welded plate heat exchanger is suitable for operation in chemically aggressive environments and for handling high-temperature fluids. It is fully accessible. And with no gaskets between the corrugated heat transfer plates, maintenance is straightforward and efficient.
