How to Avoid Corrosion and Cracking of Plates

The Negative Effects of Using Non-Alfa Laval Adhesives

Case Story

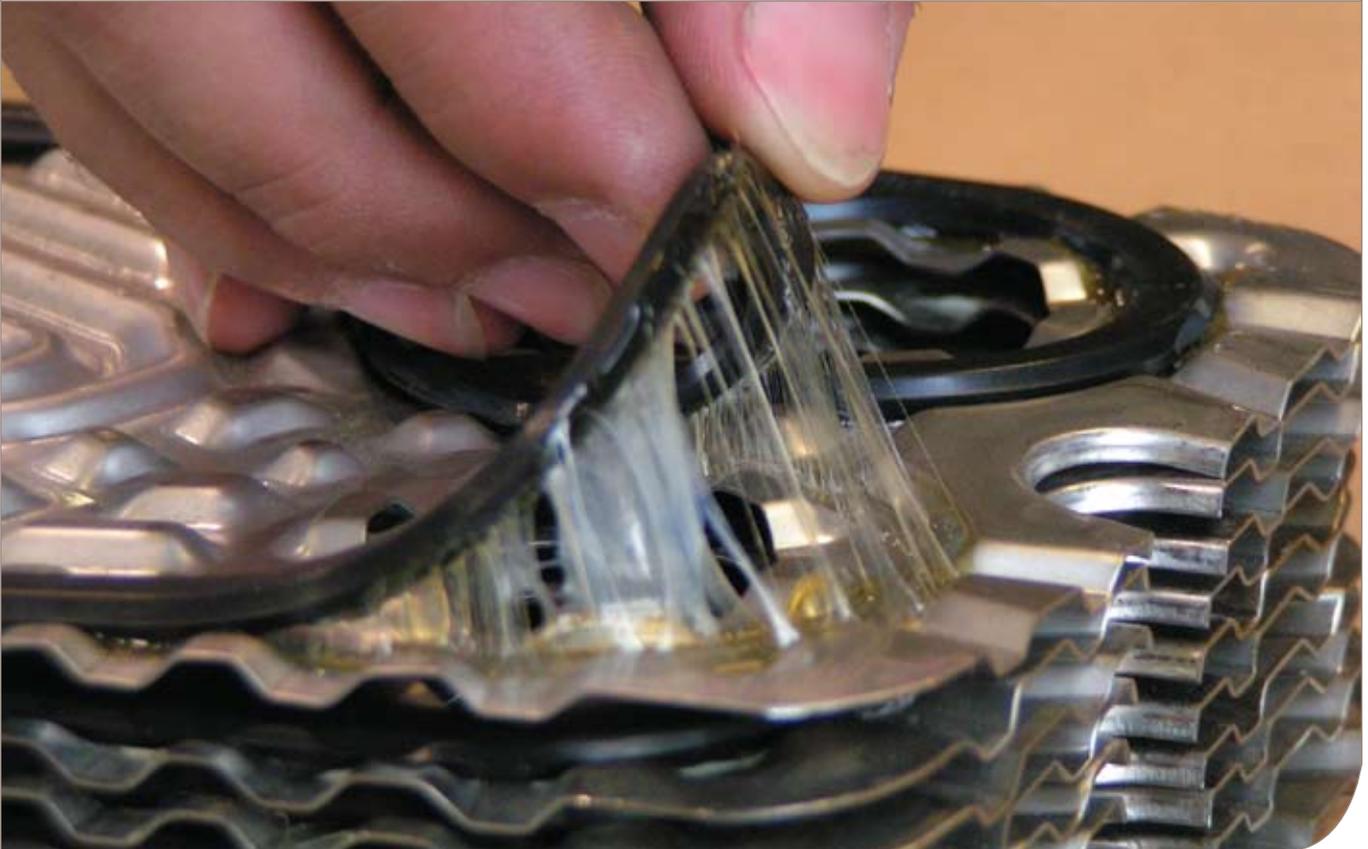
All three plate pieces showed similar advanced corrosion and cracking. The damages were mainly located at the gasket grooves and on the non-media exposed surfaces, e.g. the leakage chamber. The laboratory examination included the following findings:

- EDS analysis of glue residuals used for fixing the gaskets in the gasket grooves revealed substantial amounts of chloride.
- The red dye penetrant applied to the V85 plate revealed several perforations in and near the gasket groove.
- The media-exposed surfaces were not affected by corrosion. It was noted that glue residuals were present in substantial amounts outside the gasket grooves.
- The metallographic cross sections revealed several branched cracks, characteristic of stress corrosion type of cracking (SCC).
- EDS analysis showed that there were substantial amounts of chloride present.
- The flame test gave clear, positive indications of the presence of chlorides in the glue, which also appeared in the EDS analysis.

It was determined that the stress corrosion cracking and severe localized corrosion were caused by the use of chloride-containing glue used for fixing

To ensure that the products work as efficiently, effectively and with as long a life as possible, it is strongly recommended that only Alfa Laval approved adhesives are used. This will make sure that potentially damaging elements are not conflicting with the products.
