## Improving refinery (RAM) with Compabloc plate heat exchangers

**Reliability, Availability and Maintainability (RAM)**

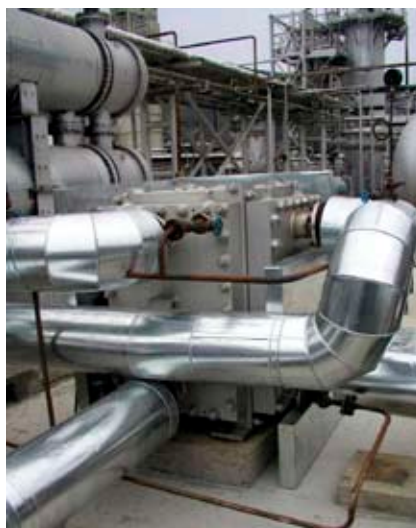
One Compabloc preheating crude since 2002 in a Russian refinery.

The country that to-date has the highest level of acceptance for CP technology is Russia. Out of 28 refineries, 27 use the technology, both to replace old shell-and-tube heat exchangers and in new process units. One of the oldest CPs in Russia is installed in a crude preheat train. It preheats crude to over 200° C using atmospheric residue as the heating media. The 170 m<sup>2</sup> stainless steel CP replaced three corroding CS shell-and-tube heat exchangers with more than 1000 m<sup>2</sup> of heat transfer surface.

Since it was commissioned in February 2002, the CP has not required any maintenance whatsoever. Due to their positive experience with this heat exchanger, the refinery has since invested in three more CPs to improve heat recovery in their crude preheat train as well as one CP that operates as a gasoline cooler in their hydrotreatment plant. The latter uses seawater as cooling media.

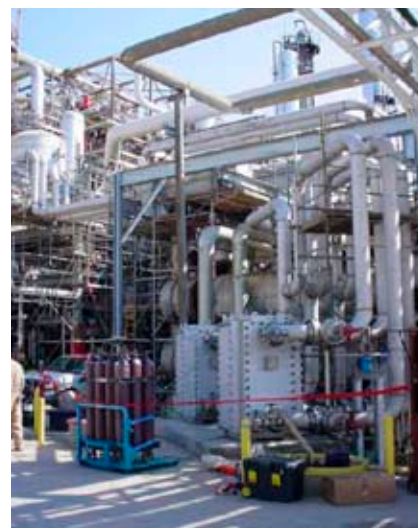
Two Compablocs preheating crude since 2004 in a North American refinery.

North American refiners have also made the leap to more modern heat transfer technologies. When one refinery wanted to expand its plant's capability to process price-advantaged crudes, new heat exchangers were needed in the crude preheat train. Due to space limitations in the plant, CP technology was chosen for the duty of preheating crude to up to 235° C using heavy vacuum gas oil (HVGO).

Because the technology was new to them, the refinery chose to install a 100% stand-by unit in parallel to

the operating CP. However, one heat exchanger alone proved to be sufficient. It operated continuously for more than 18 months without any loss of performance. The stand-by unit is used only during periods when the HVGO duty needs to be maximized. It then operates in parallel with the other CP. The refinery says that the plate technology has paid for itself many times over, and they are now considering using plate technology in their next revamping project.

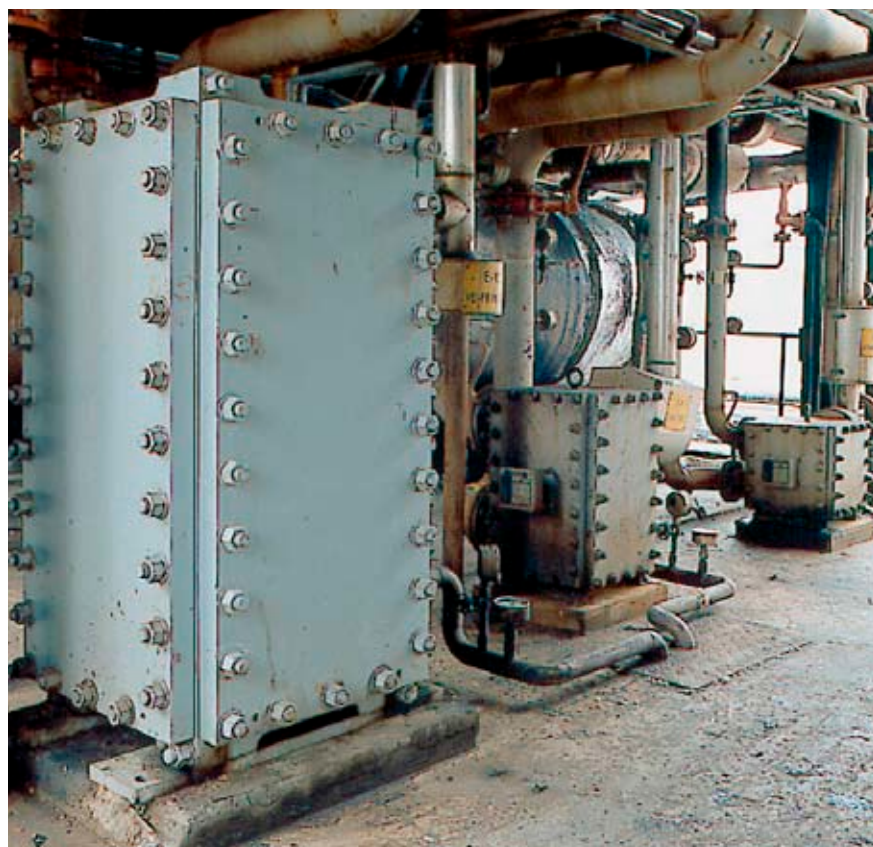
Three Compablocs operating since 1996 as ADU fraction coolers in a northern European bitumen refinery.

One of the longest operating CP installations is in a bitumen refinery in northern Europe. Here, 14 CPs are in operation, the oldest since 1996. They have all replaced low-performing, high-fouling and corroding shell-and-tube heat exchangers. The CPs are used for various duties, such as ADU fraction cooling, VDU overhead vapour condensing and bitumen heating and cooling.

The old shell-and-tube heat exchangers required cleaning and inspection yearly, an operation that took one week. The CPs, on the other hand, require chemical cleaning only every third year, and it is easily carried out in a single day. In total, for these 14 units, the refinery has reduced maintenance costs by 96%!

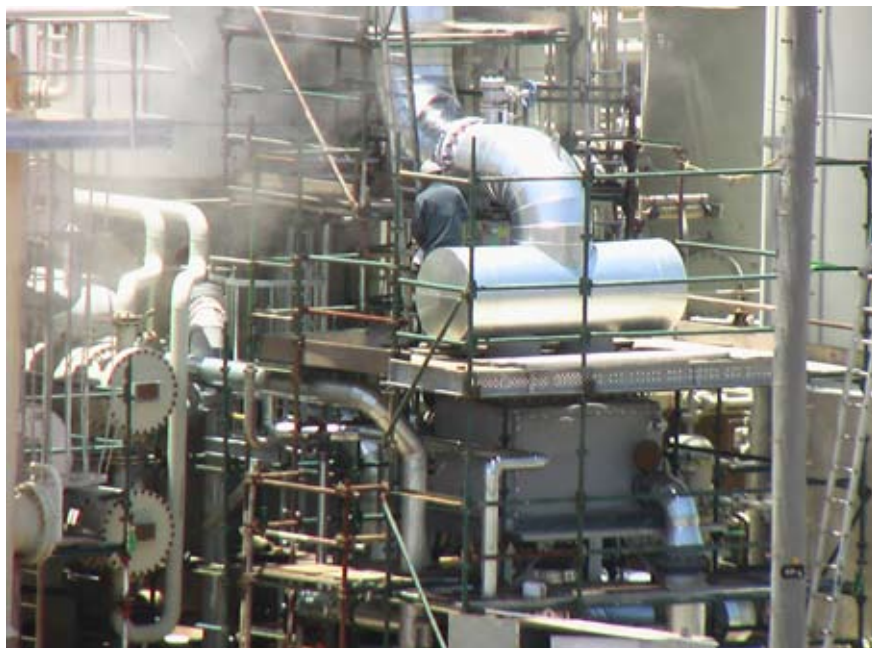
One Compabloc operating since 2006 as naphtha reboiler in an Australian refinery.

A final example proving that CPs provide both high availability and versatility, is a case from Australia. In this refinery, a CP has been operating since the beginning of 2006 as the thermosiphon reboiler in the naphtha splitter. The CP operates in parallel to and as a booster for an existing shell-and-tube reboiler. The shell-and-tube reboiler requires cleaning every six months, while the CP can operate for almost a year in between maintenance.

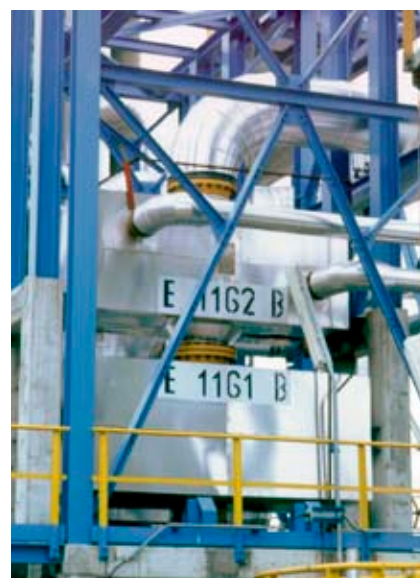
Two out of four Compablocs operating since 1997 as ADU overhead vapour condensers in a European refinery.

One installation that provides proof of both long uptime and ease-of-maintenance is in a European refinery where four titanium CPs are used for maximum heat recovery from the ADU overhead vapours.

Both crude and boiler-feed-water is preheated by means of two CPs operating in series. The two parallel lines are installed high above ground, next to the distillation tower.

The first cleaning took place in 2002 after five years of operation. The cold circuits, crude and boiler-feed water, did not require any cleaning, while the vapour circuit was cleaned, mainly to remove salt crystals formed in the heat transfer channels.

Chemical cleaning alone was used to restore the performance. First, hydrocarbon-related fouling was removed by circulating a heated caustic solution. Then, after rinsing, salts such as iron sulfide, were removed using a sulfamic acid cleaning agent. Finally, the CS

pipings was neutralized and passivated by circulating a sodium carbonate solution through the CP. Before the heat exchanger was put back into operation, it was rinsed with demineralized water. The entire cleaning procedure took around three days.

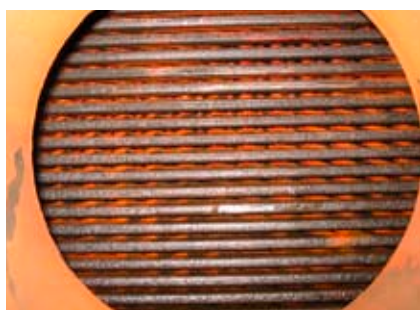
Endoscopic photo of hot stripped water circuit taken from the inlet nozzle of a Compabloc operating since 2003 as interchanger in a SWS unit in a South America refinery. Photo shows before and after chemical cleaning.

Another example of successful chemical cleaning comes from a South American refinery. Here the CP operates as an interchanger between sour and stripped water in the SWS process. Due to the acidity of the sour water, the carbon-steel stripping tower suffers from corrosion problems, and iron oxides and sulfides enter the hot circuit of the CP with the stripped water. The heat exchanger must be chemically cleaned frequently to restore its performance.

First, the CP is flushed with hot water, and then a weak, heated caustic soda solution is circulated through its channels. After a second flushing with water, a weak, heated phosphoric acid solution is used. Finally, before the heat exchanger is put back into operation, it is flushed a third time with hot water.

The cleaning procedure takes around one shift, and the result is verified by means of endoscope photos of the heat transfer channels taken from the connection nozzles.

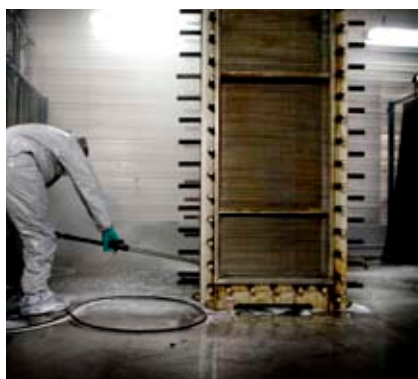
This means the hydro-jet passes through the heat exchanger when the nozzle is tilted in 45 degree angle.

Because the plate pattern is specifically made at a 45-degree angle, unrestricted channels are formed in this direction. Furthermore, the non-corrugated, flat channels at the edges of the plates efficiently drain the foulant out of the heat exchanger. By tilting the high-pressure water lance at a 45-degree angle, the entire plate area can be accessed if the plate pack is cleaned first from the front and then from the back.

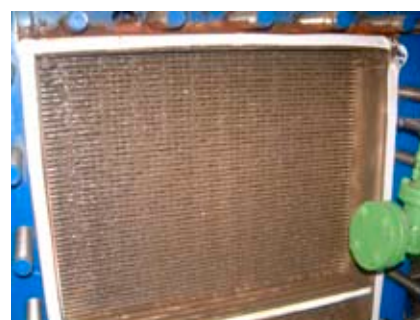
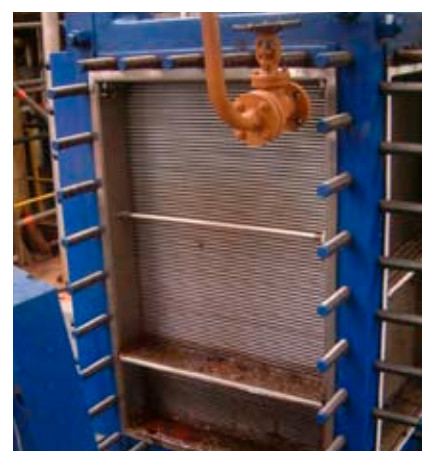
Photo showing before and after high-pressure water-jet cleaning of the cooling water circuit of a Compabloc operating as condenser in the solvent recovery part of a paraffin removal plant in Europe.

In a European lube oil plant, a CP has been in operation since 2004 as a condenser in the solvent recovery part of the paraffin removal plant. It needs regular cleaning every 12-15 months due to calcium-carbonate scaling on the cooling-water side. It is cleaned with high-pressure water of 800 – 1000 bars, using heated water and either rotating nozzles or nozzles with narrow spraying angles. The cleaning procedure, which includes opening, cleaning, closing and tight-testing, takes eight hours and can be carried out during one shift.

The CP replaced three carbon-steel shell-and-tube heat exchangers that had problems with corrosion. The same cleaning procedure (including opening, cleaning, closing and tight-testing) for those heat exchangers took 2-3 days.

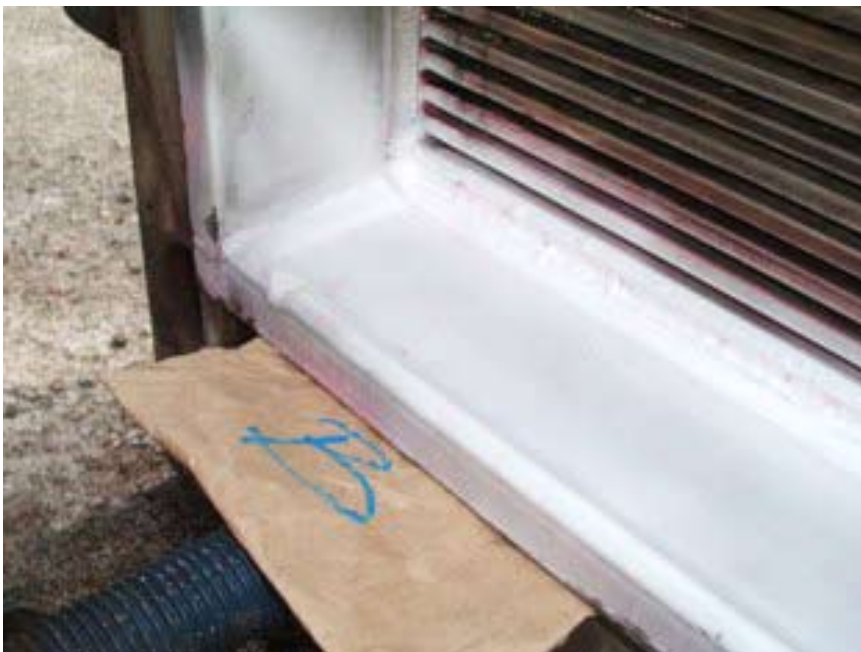
Here the result of the dye-penetrant test after a corner weld has been TIG repaired.

Repairing the CP is facilitated as all welds are external and accessible once the panels are removed. Manual TIG welding is used to repair all types of leaks. To avoid oxidation, the welding must be done with argon gas shielding.

After a weld has been repaired, its quality is tested using any or several of the following methods: air-bubble test, dye-penetrant test, hydrostatic-pressure test or helium-leak test. However, before any repair work can begin, the leak has to be identified and localized.

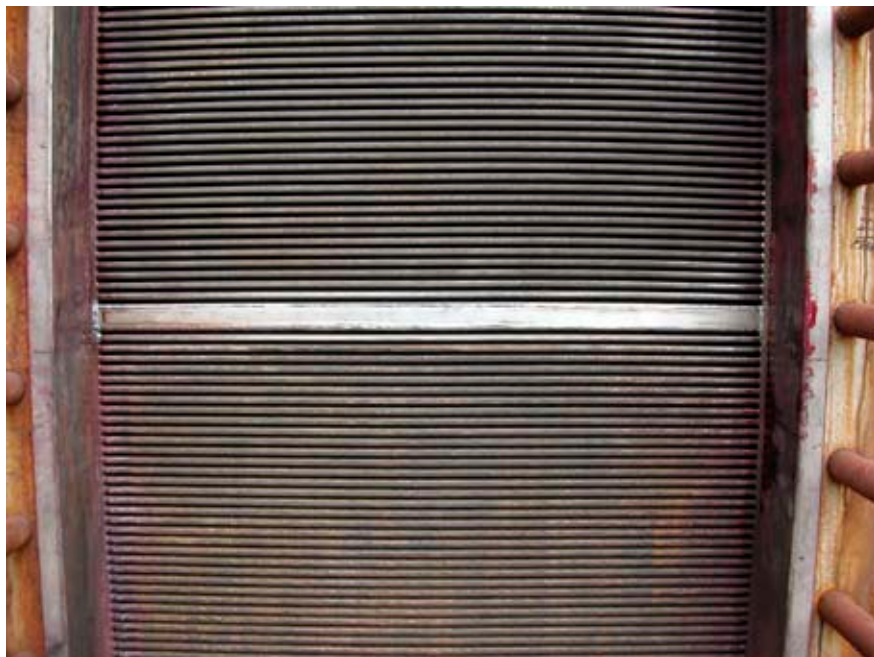
Photo showing a cross-leaking Compabloc channel sealed with a metal-strip.

However, in the rare instance that a hole does develop in a heat transfer plate, the CP can be repaired in exactly the same way as a shell-and-tube heat exchanger with a cross-leakage: by sealing off the damaged channel.

In a shell-and-tube heat exchanger, it is easy to seal off such a channel by plugging the tube with a rubber plug. Sealing off a CP channel requires manual TIG welding of a metal strip to cover the entire plate channel.
