Ilva Steelworks: Smart investment to ensure continual processes

Reconditioning spiral heat exchangers

Case story

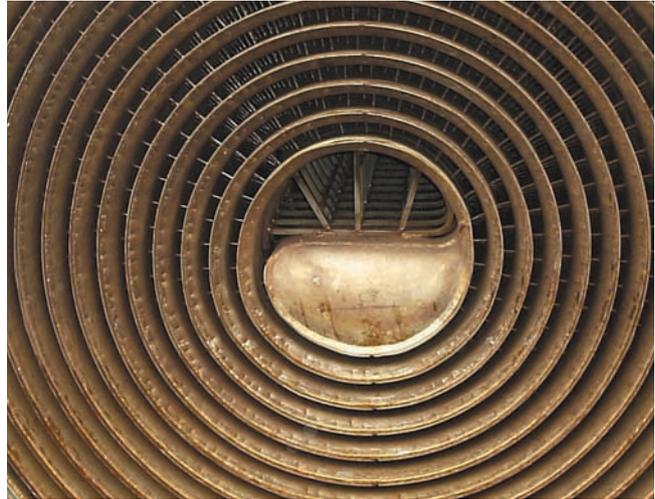
As mentioned, heavy corrosion was visible on the carbon steel covers, flanges, bolts and spiral supports. By employing sandblasting techniques, Alfa Laval was able to restore clean, rust-free surfaces to components that were not severely corroded. Parts that were too badly damaged by corrosion were replaced with new ones, in some cases, using stainless steel rather than carbon steel to enhance corrosion resistance. Existing carbon steel flanges were replaced with titanium flanges according to Alfa Laval's recommendations.

Detail of a spiral heat exchanger before Alfa Laval reconditioning.

The reconditioned carbon steel components were painted and the spiral heat exchangers were re-assembled, packed and shipped to the Taranto Steelworks.

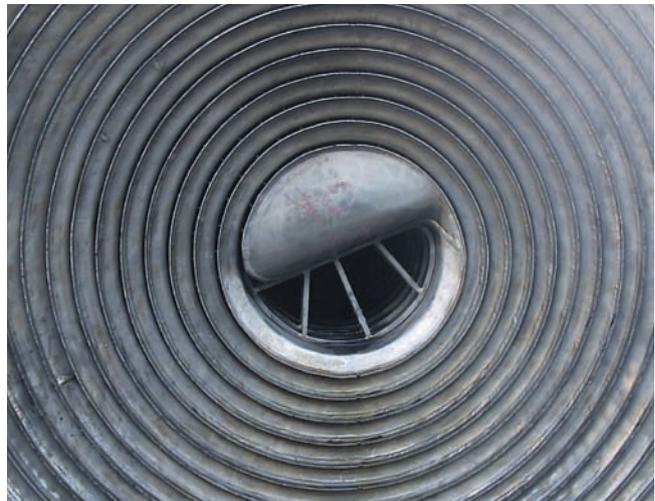
The same Alfa Laval spiral heat exchanger after reconditioning.
