Performance Audit optimizes the steam cracker of a global petrochemical company

Antwerp, Belgium

Case story

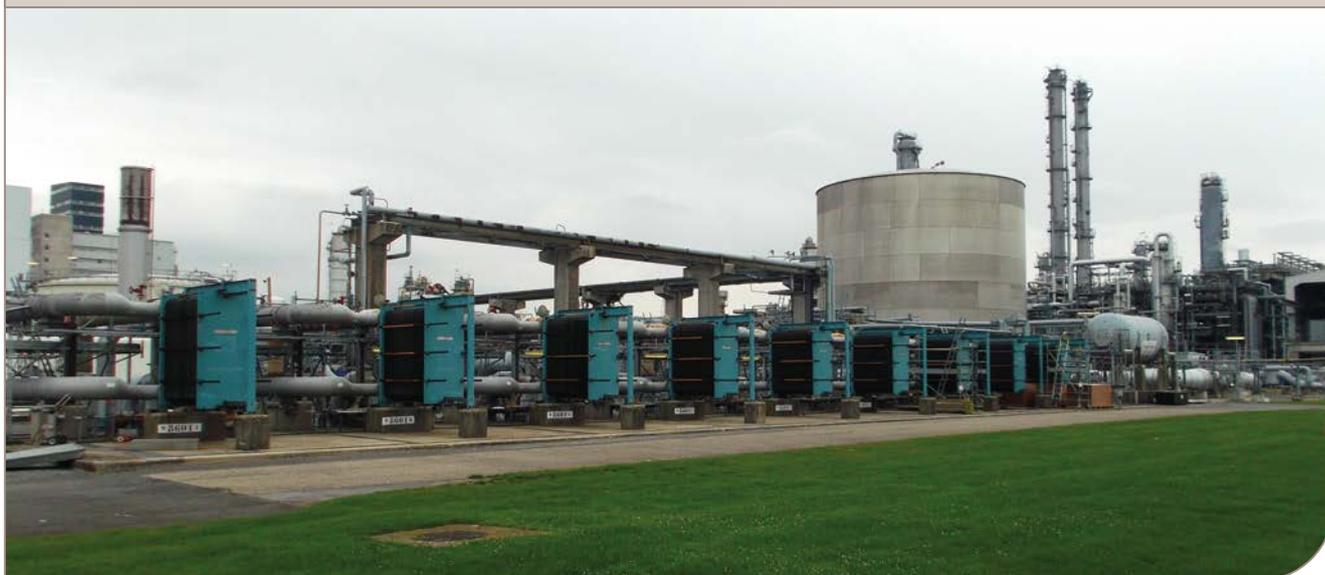
Nine Alfa Laval M30 units are responsible for cooling down the process water of the steam cracker.

“The gaskets were near the end of their lifetime. This could cause unplanned maintenance of the units. Therefore we concluded together to take this opportunity to perform a complete Alfa Laval Reconditioning Gasketed Plate Heat Exchanger in our Alfa Laval Service Centre in Waalwijk (NL). This included gaskets change, chemical cleaning of all plates and a plate integrity inspection. We then brought the plate number up to 493 for each heat exchanger and replaced low-theta plates with high-theta plates to improve the performance,” says Moolenaar.

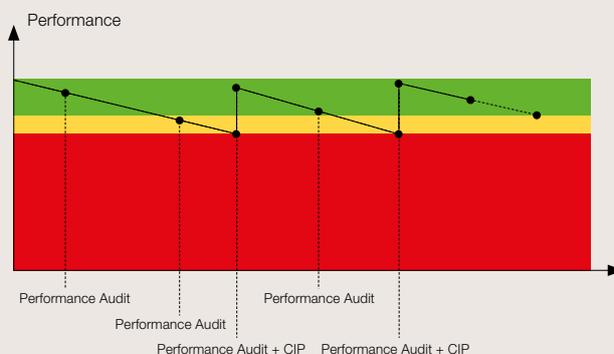
To monitor the performance of a plate heat exchanger, Alfa Laval needs to know the actual inlet and outlet temperatures for both fluids and the actual flow for one of them. Without disrupting operations, an authorized

Alfa Laval service engineer affixes four temperature gauges and one flow gauge to the outside of the heat exchanger pipes and collects data using a portable logger. The data is then analyzed with AlfaCheck software and a report is generated. Based on this report the customer can decide how and when to service the plate heat exchanger.
